HISTORIC PRESERVATION BOARD

AGENDA

December 1, 2011 - 4:00 PM

Project Description
St Monica Catholic Church
Social Hall Addition

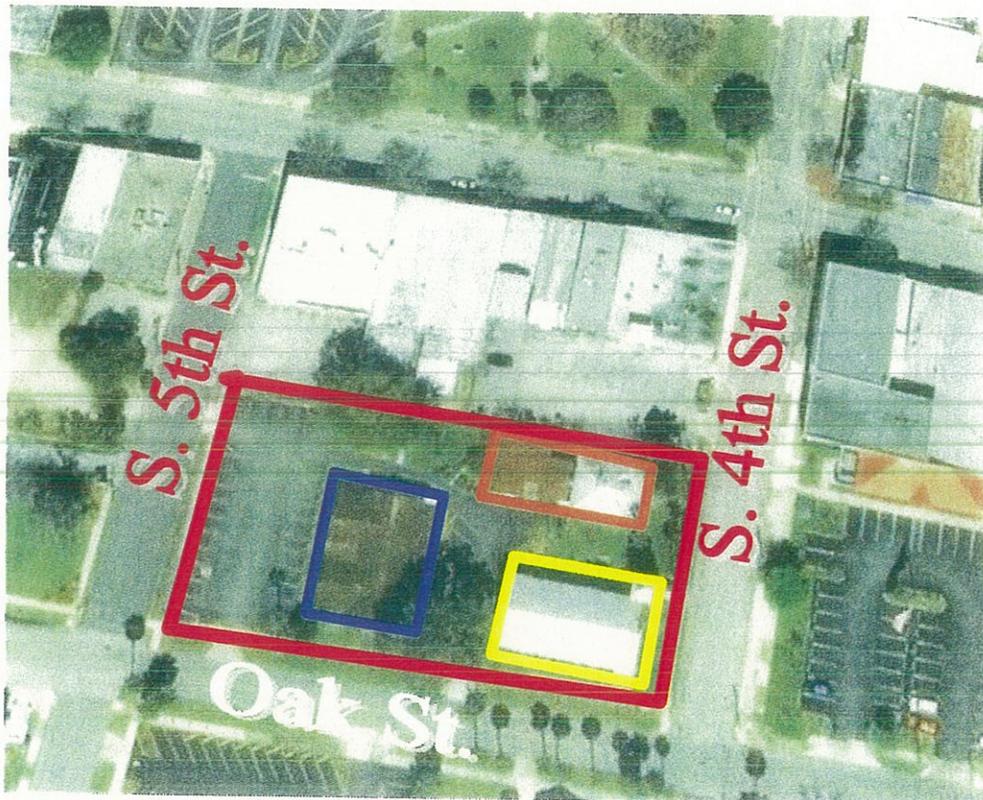
Figure 1: Property Location – the Social Hall is shown in Blue, the Church in yellow, and the Priest's House and garage in orange.

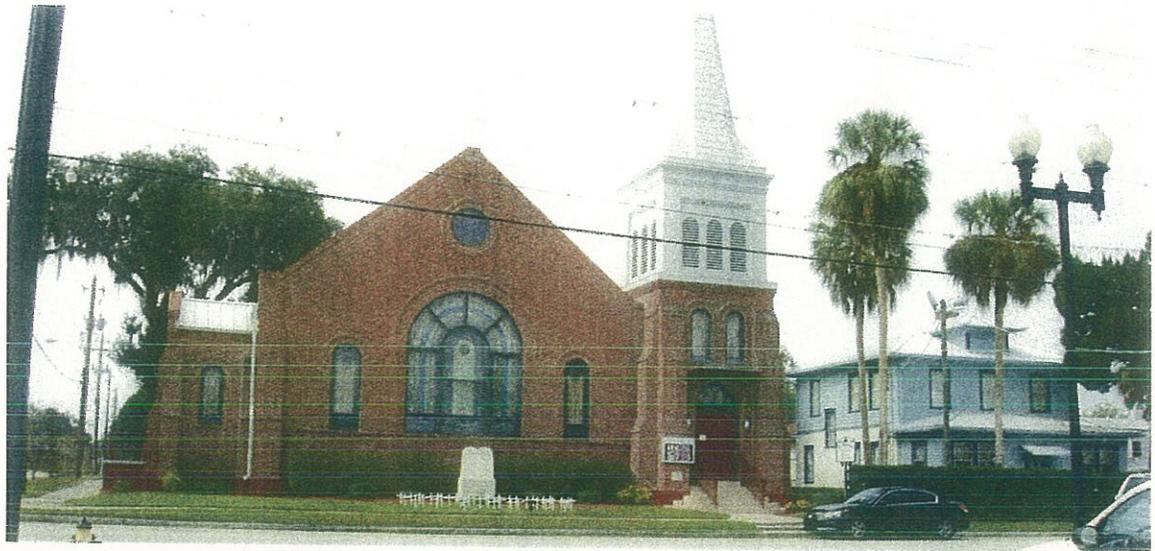
Figure 2: Church and Priest's residence from S. 4th St. – Social Hall is behind Church (above)

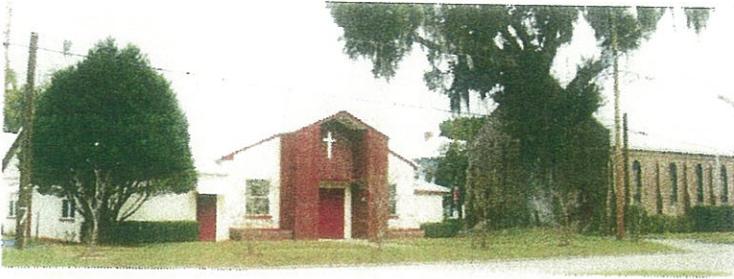
Figure 4: Social Hall from Oak St. (south)

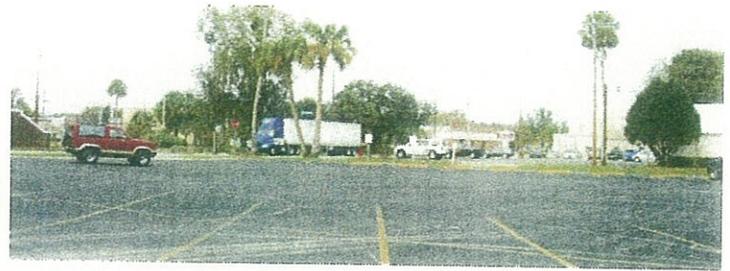
Figure 5: Areas to the south and west are parking lots or undeveloped.

Staff comment: As noted, the addition will not affect the architectural or historic value of the adjacent historic church structures. The properties that the building faces and relates to are parking lots or undeveloped lots – therefore the impact on nearby historic properties will be minimal.

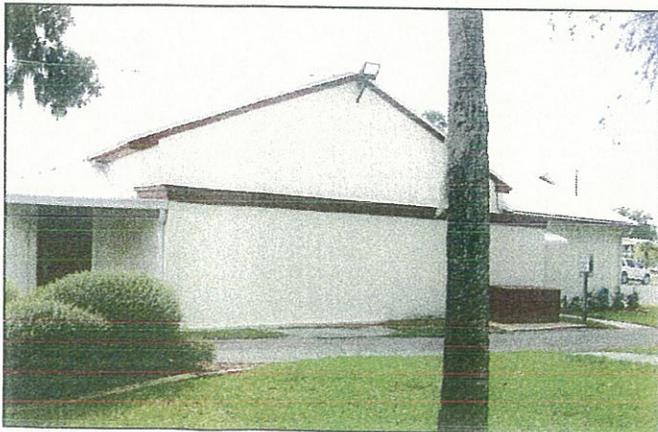
View from the North portion of church property
The side of the hall that will change with addition

The project referenced is an addition to the existing Social hall at the listed address. The addition will be added to the North end of the existing structure and will be approximately 40 feet by 55 feet (see dwg. 3 of 6).

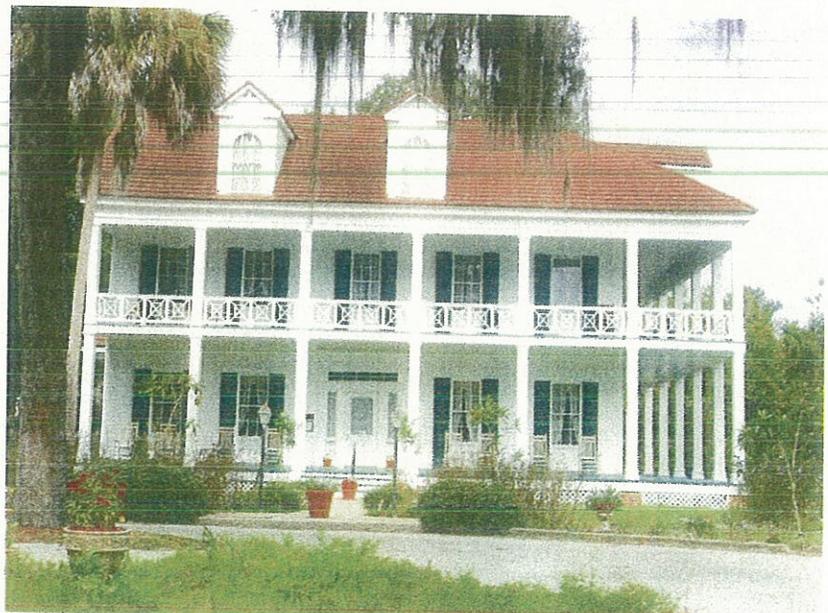
Figure 3: House from front (south). HVAC would be located behind east porch (right side).

Staff comment: the HVAC location is to the rear of the building, in the northeast corner of the east side, and will not be easily visible from the south-facing main façade, which is the building's front and most significant facade. The concrete pad and HVAC unit itself will be further screened by the metal fence.

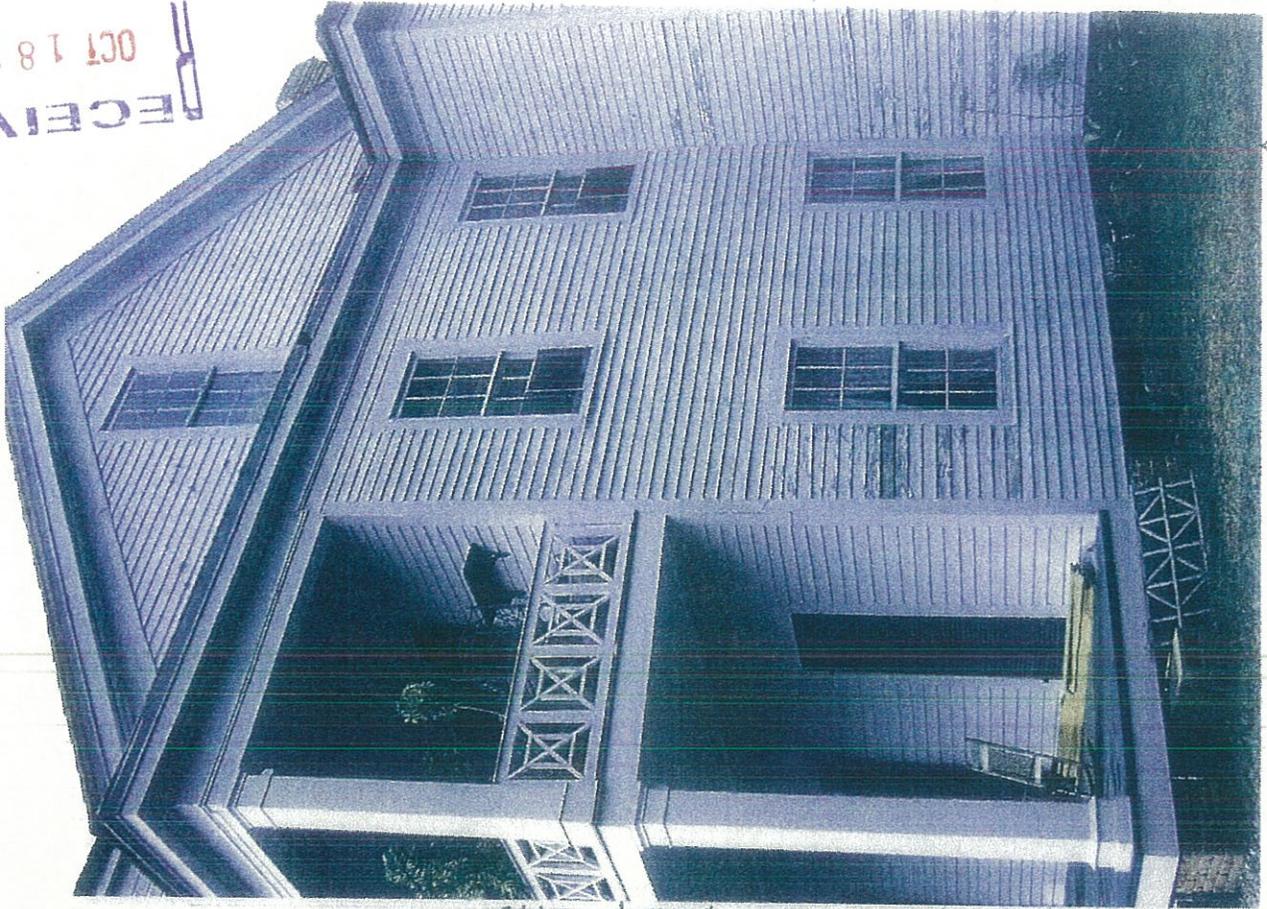
NORTHEAST CORNER EAST SIDE

Location of AIC
↓

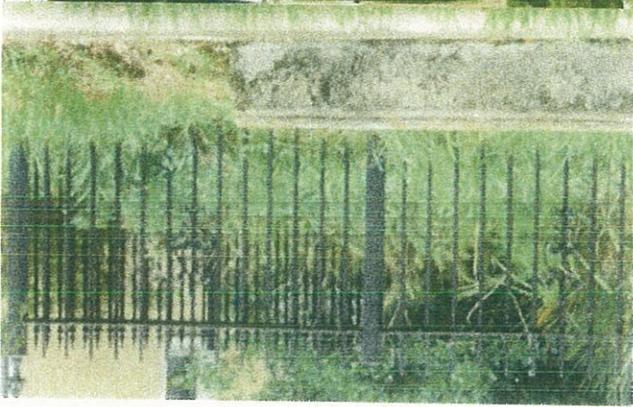
Figure 2: probable original wrought iron fence, Madison & N. 4th

Most fences in the North and South Historic Districts, in historic and present times, were and are wood picket fences, typically three to four feet tall. Staff did locate one wrought iron fence in the North Historic District (N. 4th St. & Madison, picture on previous page), which appears to date to the pre-WWII historic period of significance for the district. In addition one oxidized and historic wrought iron fence was found in the South Historic District, and four new aluminum fences in the South District resemble the black wrought iron material.
